**U.S. DEPARTMENT OF ENERGY**

**Rulison Site**

**END STATE VISION**

***Final – Rulison Site Environmental Management End State Vision – January 2005***

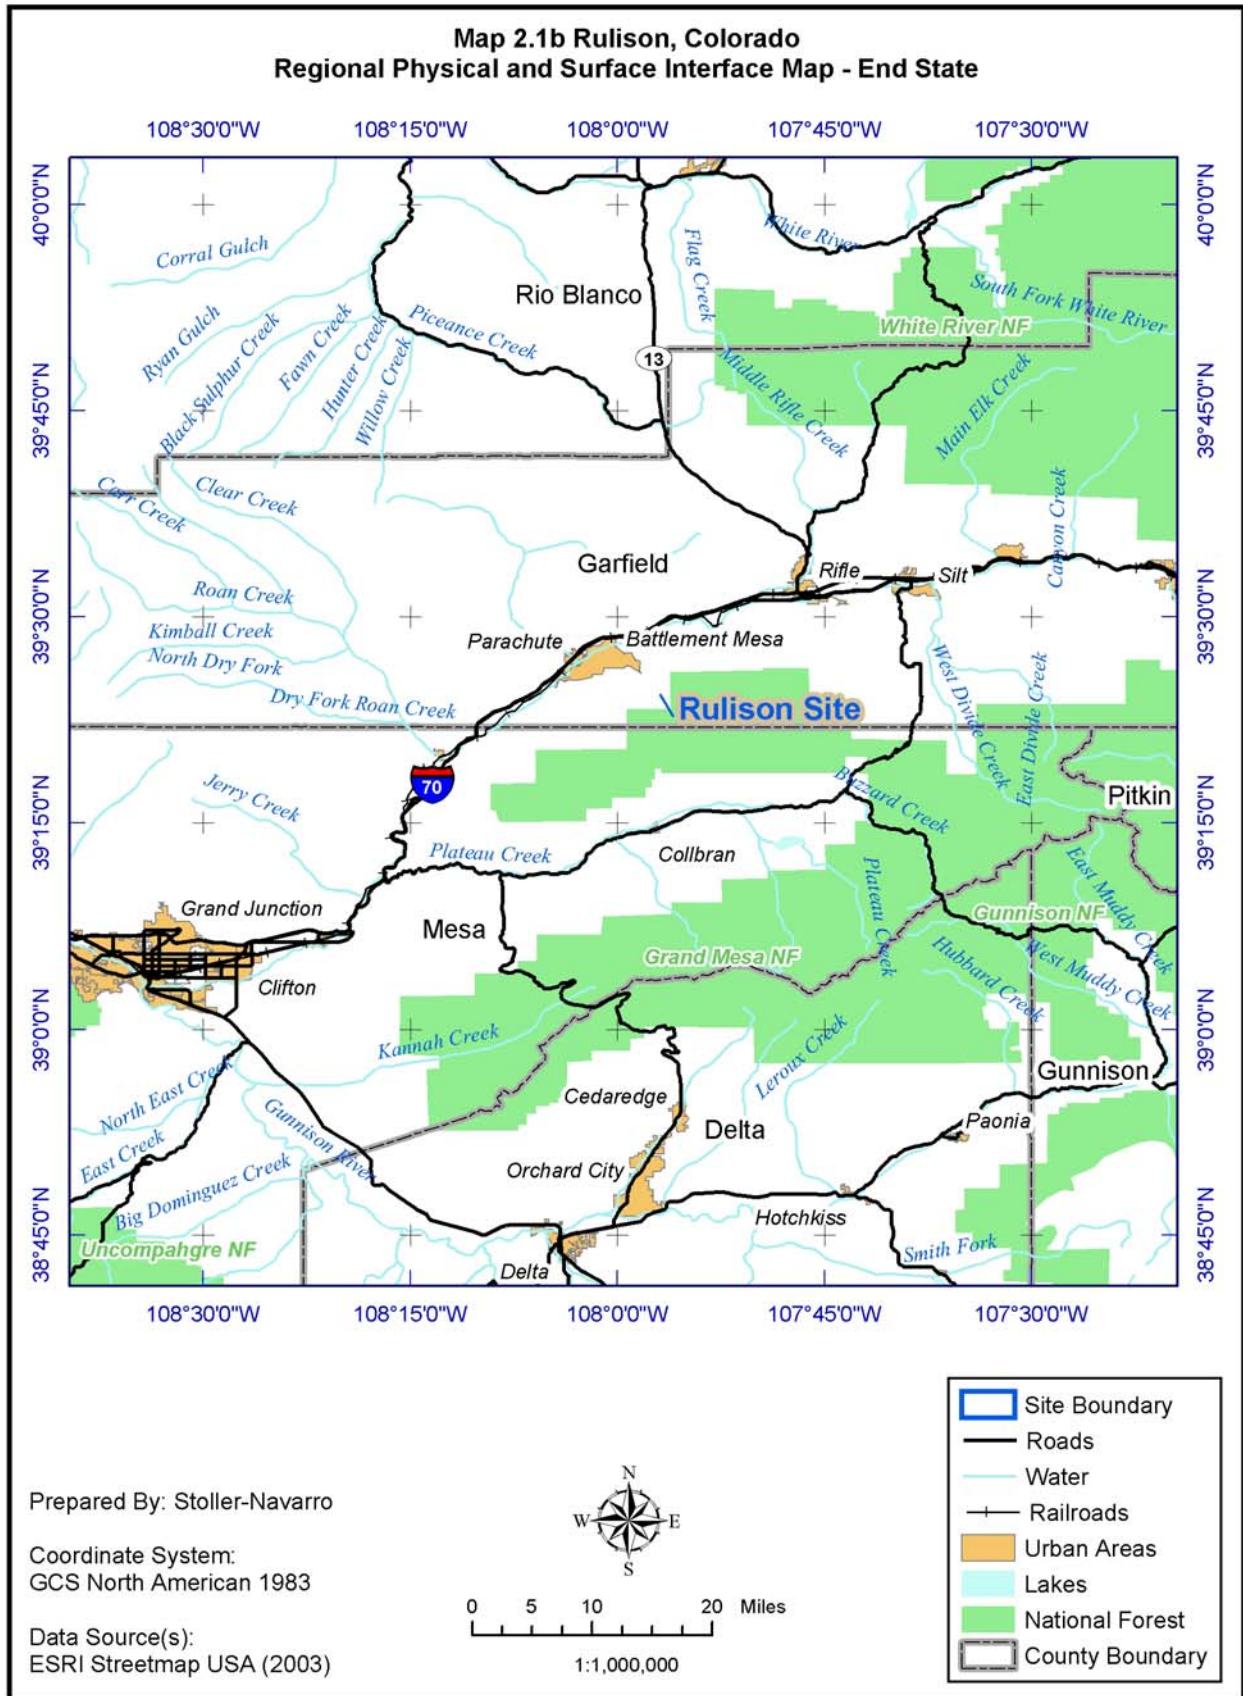
The Rulison Site is on the north slope of Battlement Mesa in southern Garfield County (Map 2.1b). The Colorado River Valley lies 8 mi north of the site. South of the site, the upper elevations of Battlement Mesa rise to over 10,000 ft. The east fork of Battlement Creek flows through the northern part of the site and discharges into the Colorado River. This region lies in a transition area between the glaciated high peaks of central Colorado and the arid canyon country of western Colorado. As such, the Battlement Mesa area contains characteristics of both regions.

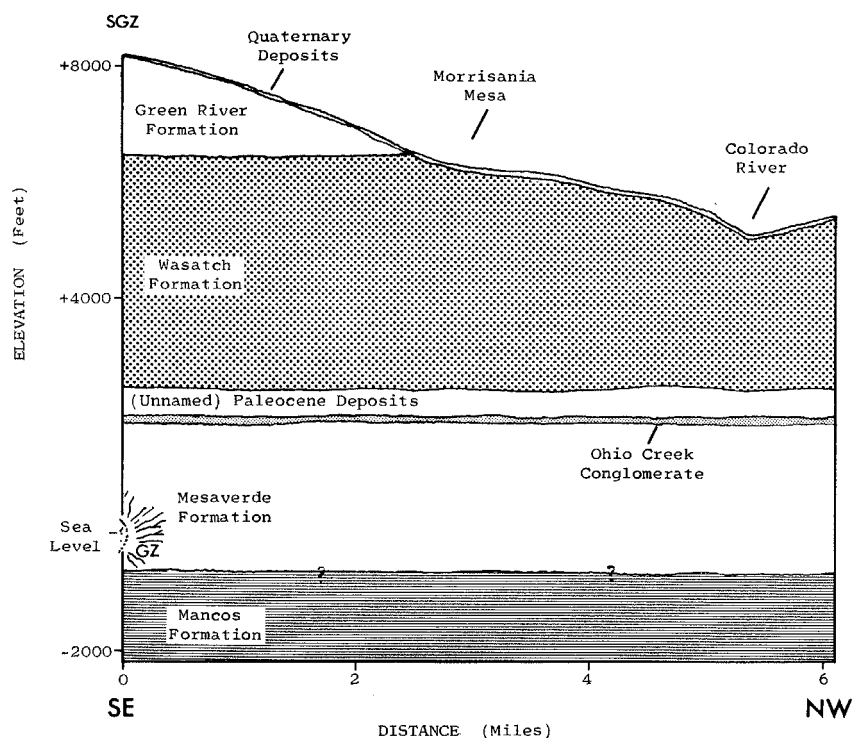
**Figure 2.0**

Diagrammatic Cross Section of the Rulison Site Along the Trend of Battlement Creek

Battlement Mesa is a basalt-capped highland that lies in the southern part of the Piceance Basin in northwestern Colorado. The Piceance Basin has produced oil and natural gas, coal-bed methane, and coal from the Tertiary Wasatch and Mesaverde Formations. The Piceance Creek structural basin is a large northwest-trending downwarp underlying northwestern Colorado. The Rulison Site is on the southwest limb of this basin such that beds penetrated by site boreholes dip gently northeastward. The basin contains about 27,000 ft of sedimentary rock. The Mancos Formation contains pro-deltaic marine mudstones and underlies the nuclear test horizon (Figure 2.0). The Rulison test was conducted in the Mesaverde Group, which is approximately 2,500 ft thick at the site. The Mesaverde Group is predominantly non-marine and consists of sandstone, shale, and coal deposited during the eastward advance of a large deltaic and coastal plain complex into a retreating sea. As a result, sandstone occurs in discontinuous lenses, many of which only extend for distances of a few thousand feet, interbedded with shale.

Above the Mesaverde Group is the Ohio Creek Formation. It is relatively thin in the area of the Rulison Site (37 to 76 ft thick) and is comprised of conglomerates, sandstones, and siltstones. Above this is an approximately 500-ft thick unnamed Paleocene-age formation between the Ohio Creek and Wasatch Formations. The Wasatch Formation (3,900 ft thick at the Rulison Site) contains clay, shale, and sandstone, with local occurrences of conglomerate, limestone, coal, and carbonaceous shale. Overlying the Wasatch is the Green River Formation, which is about 1,700 ft thick at the Rulison Site and is comprised of shale and marlstone, with minor amounts of sandstone, siltstone, and limestone. The Green River Formation is the primary formation of

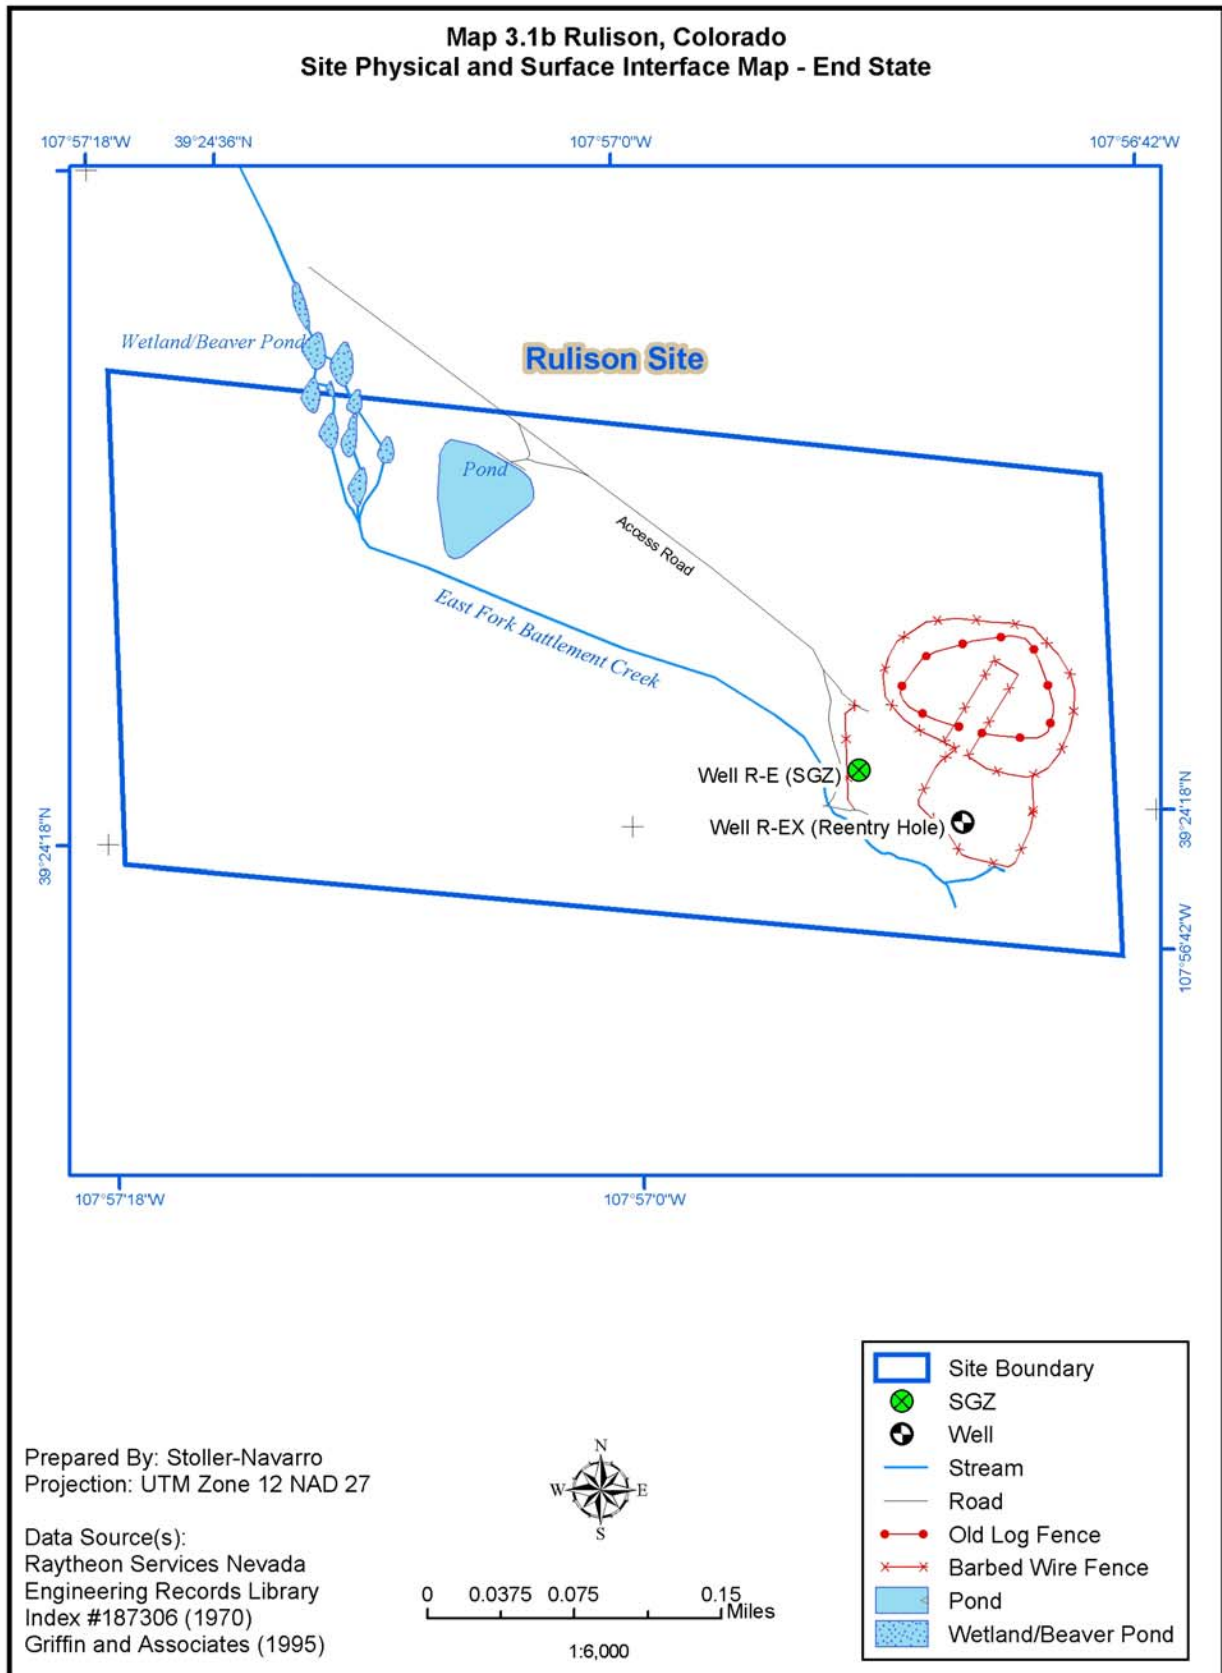
The Rulison Site (Map 3.1b) is on the north slope of Battlement Mesa in upper Battlement Creek, at an elevation of 8,200 ft. The site encompasses the locations of the drilling mud pit and overflow pond, the emplacement drill hole, and the reentry drill hole. Both drill holes have been plugged and abandoned, and the mud pits have been reclaimed. The Rulison Site has received closure for surface contamination, and no further remediation is required (DOE/NV, 1998). The land surface of the Rulison Site is in its final end state.

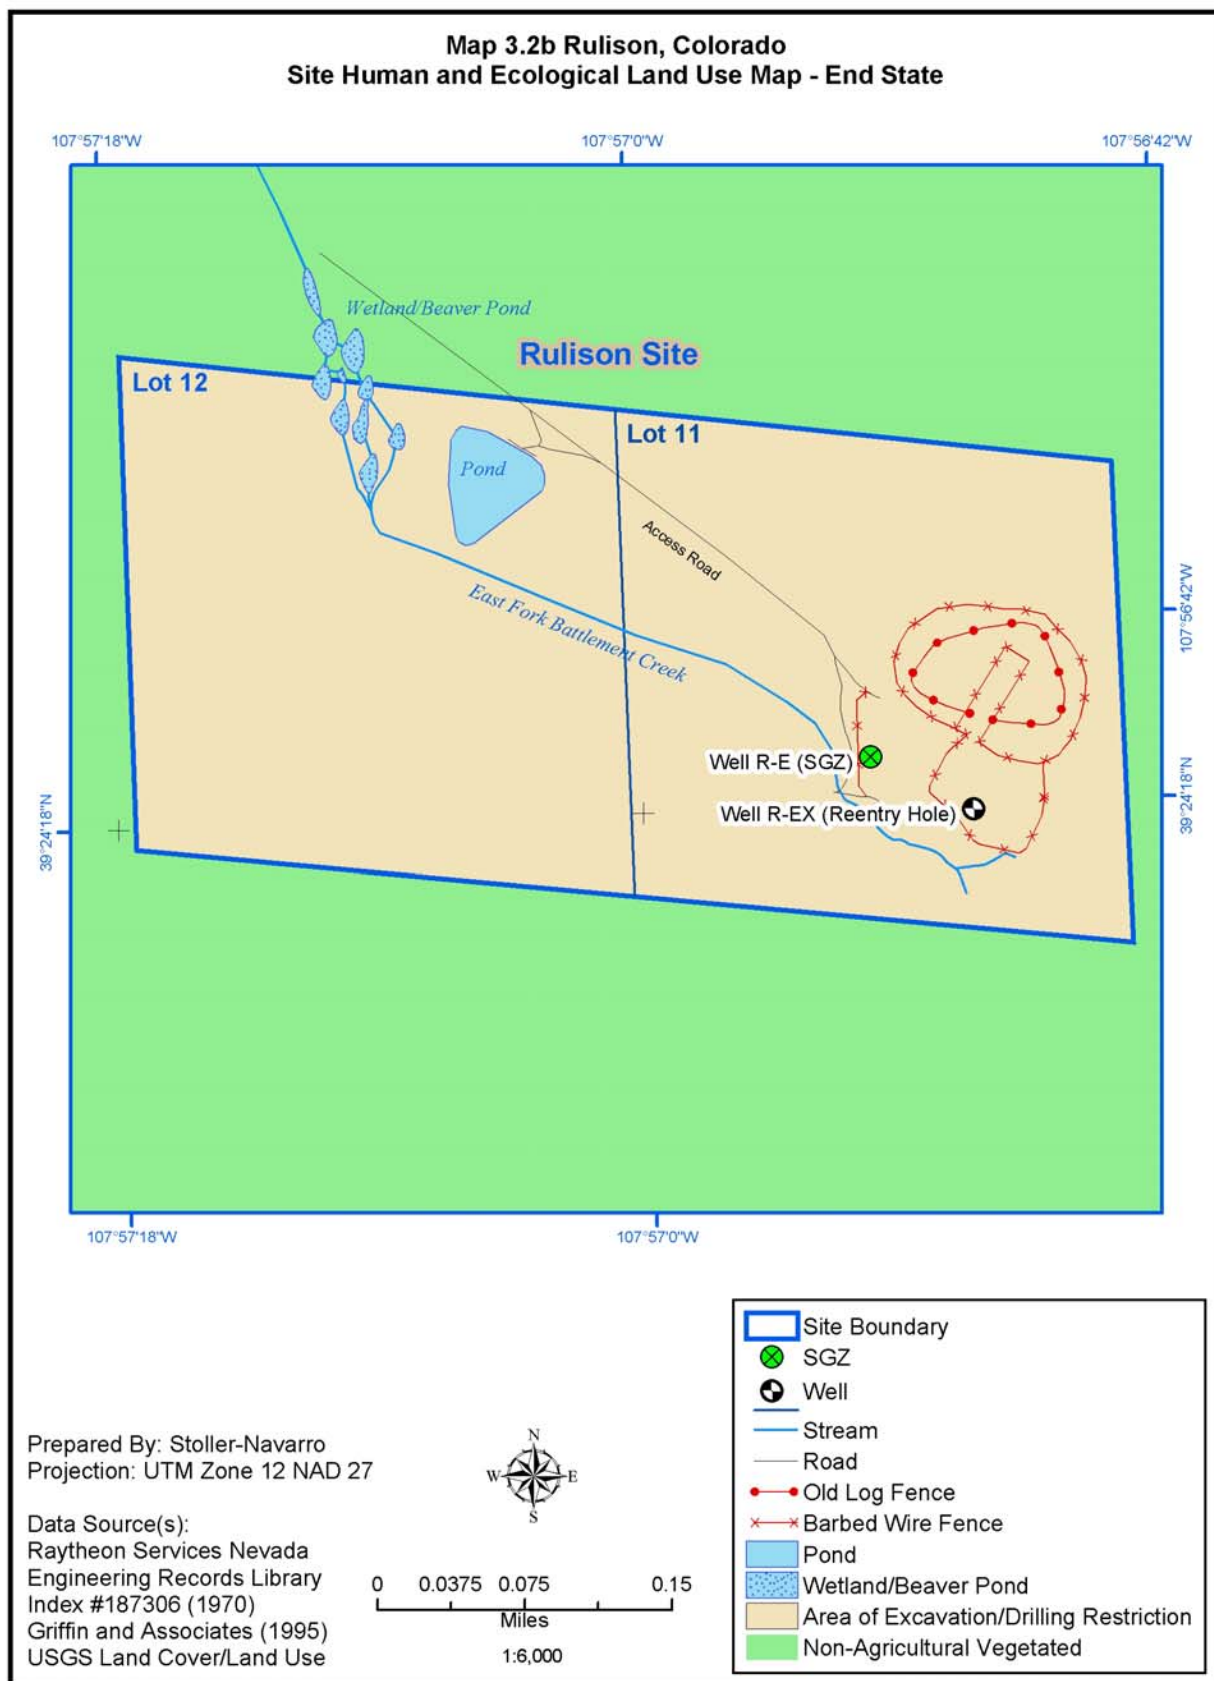
The Rulison Site is privately owned land surrounded by private land to the west, south, and east, and by BLM land to the north (Map 3.2b). A summer residence is located on the site, approximately 1,400 ft from the former drilling fluid overflow pond, which has subsequently been converted into a fishpond. The site is used for livestock grazing and for recreation, including fishing. There are currently no mining claims and no oil and gas leases on the site. Future use of the site is anticipated to remain the same (IT, 1996).

Subsurface use restrictions at the Rulison Site will remain in place in perpetuity. These restrictions, shown in Map 3.2b, are described on the permanent monument located at the SGZ on site. The restrictions are as follows:

“No excavation, drilling, and/or removal of subsurface materials below a depth of 6,000 ft is permitted within Lot 11, NE ¼ SW ¼ of Section 25, Township 7 South, Range 95 West, 6th Principal Meridian, Garfield County, Colorado, without U.S. Government permission. U.S. Energy Research and Development Administration” (Johnston, 2003a).

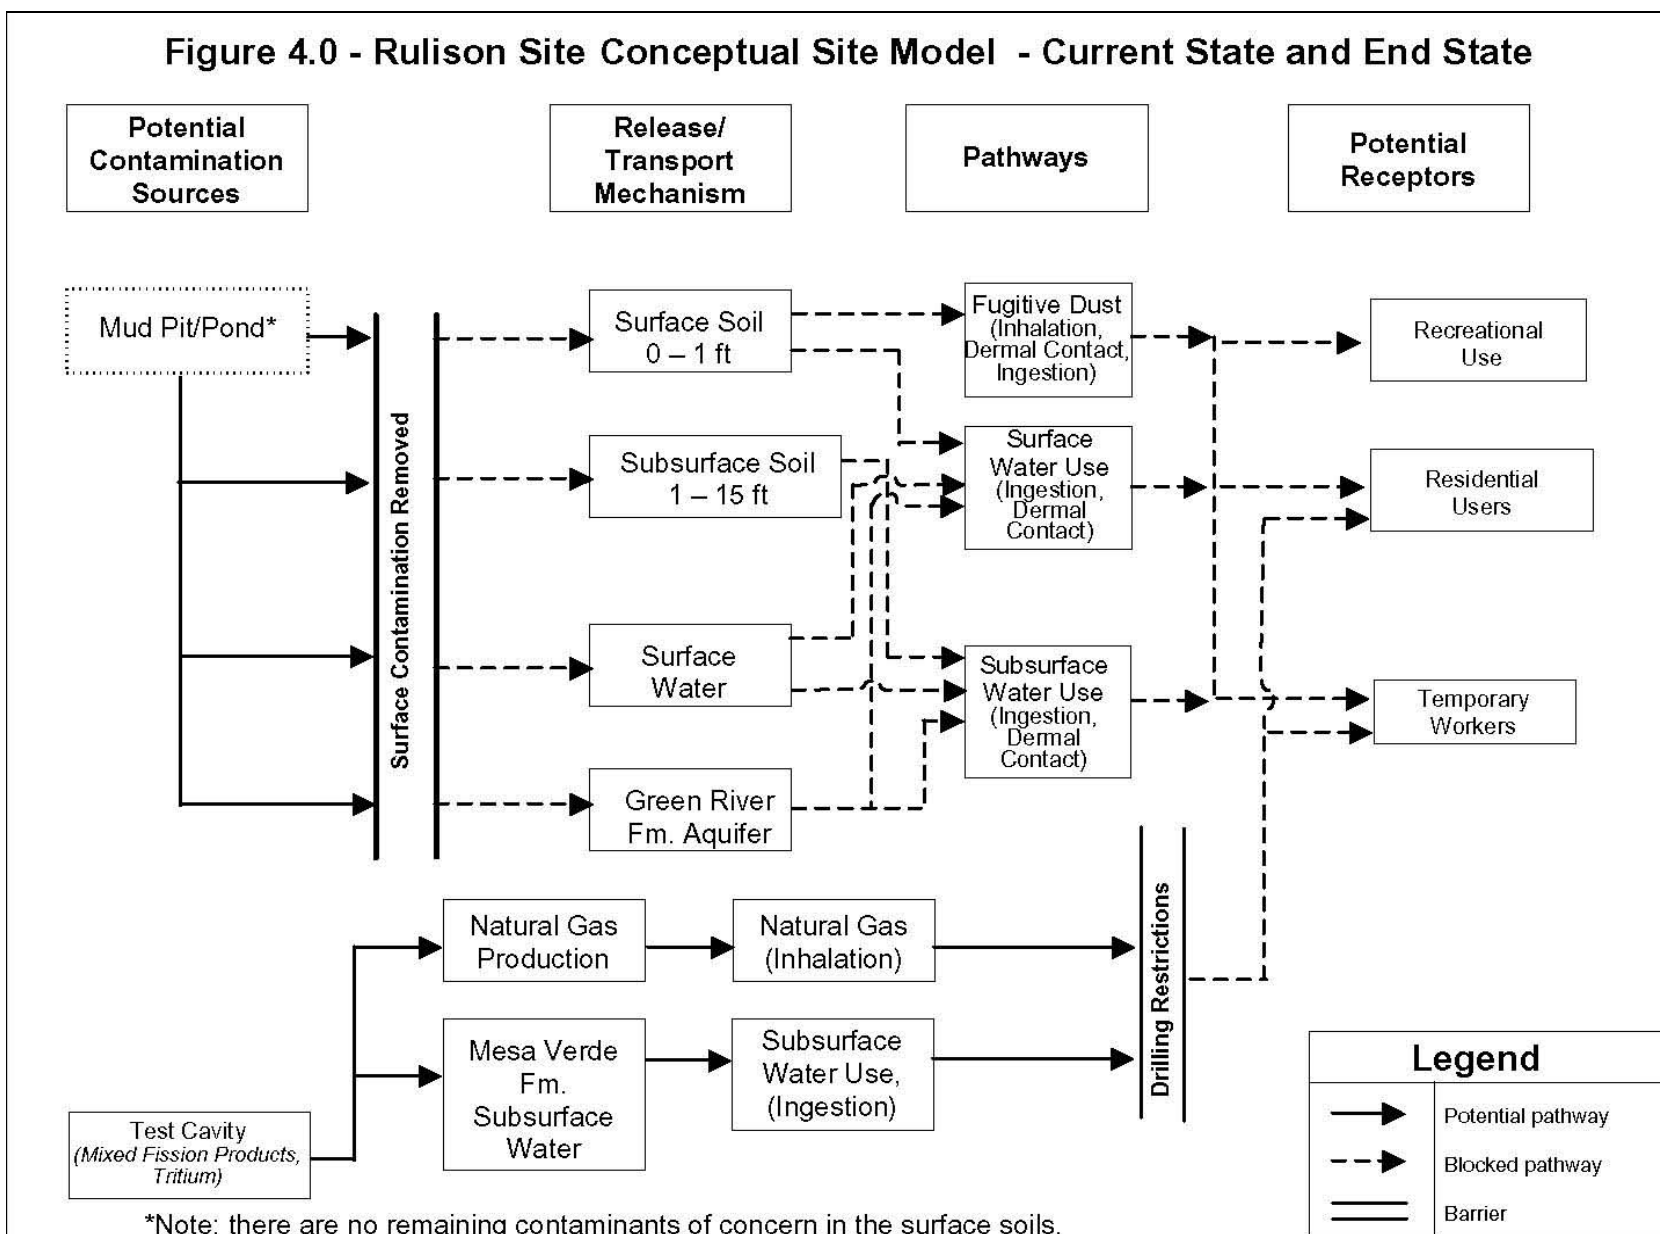
Figure 4.0 - Rulison Site Conceptual Site Model - Current State and End State

A CSM for the site is provided in Figure 4.0. The CSM illustrates the relationship between the identified potential sources of contamination, the mechanisms for release and migration away from the potential source, the pathways the contamination would follow once released, the exposure routes by which potential contamination would affect receptors, and the receptors that would be impacted by potential contamination.
